To Whom it May Concern:

The following is a Summary of the Findings and Recommendations of the Roof IR Condition Assessment:

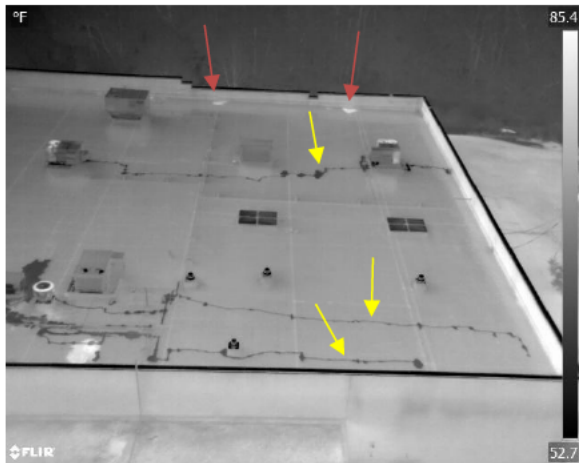
#5: VIEW FROM SOUTH SHOWING SECTIONS A,B,D. RED ARROWS POINT TO POSSIBLE ANOMALY. YELLOW ARROWS INDICATE SURFACE MOISTURE FROM HVAC UNITS.

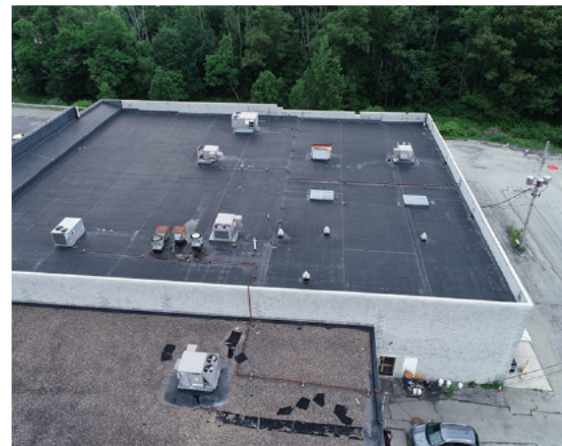
#6: VIEW FROM SOUTH SHOWING SECTIONS A,B,D

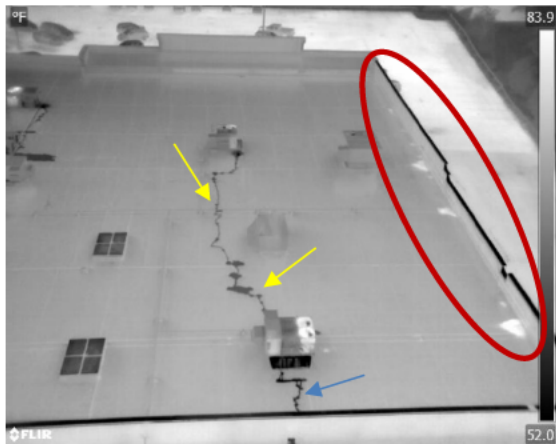
#7: VIEW FROM EAST (BACK SIDE) SHOWING SECTIONS A,C,D,E,F. RED CIRCLE INDICATES POSSIBLE ANOMALY ALONG NORTH WALL OF STRUCTURE. MAYBE CONSISTENT WITH WATER TRAPED UNDER ROOF MEMBRANE. YELLOW ARROWS INDICATE SURFACE MOISTURE FROM HVAC UNITS COMING FROM C2. MOISTURE LINE (BLUE ARROW) APPEARS TO BE COMING FROM A1, BASED ON THERMAL SIGNATURE.

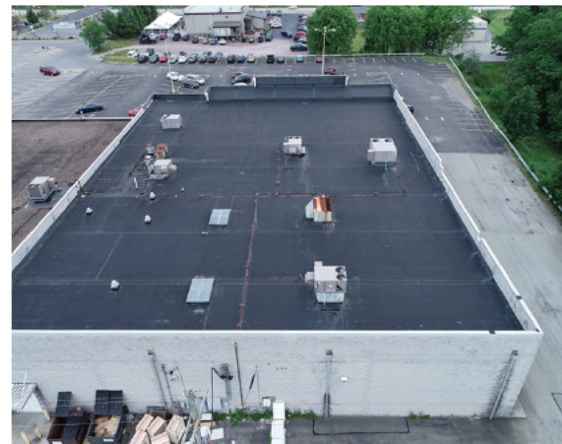
#8: EAST/BACK SIDE OF STRUCTURE SHOWING SECTIONS A,C,D,E,F. VISABLE WATER LINES AROUND HVAC UNITS.

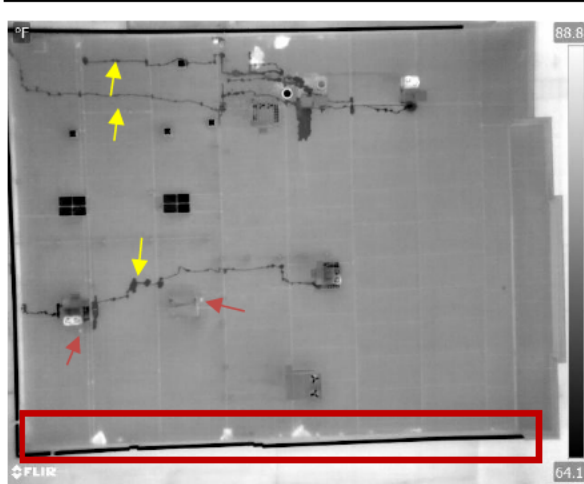
#9: BIRDS EYE VIEW OF STRUCTURE. RED BOX INDICATES POSSIBLE ANOMALY ALONG NORTH WALL OF STRUCTURE. MAYBE CONSISTENT WITH WATER TRAPED UNDER ROOF MEMBRANE. YELLOW ARROWS (SECTIONS A AND B) INDICATE SURFACE MOISTURE FROM HVAC UNITS. RED ARROWS POINT TO POSSIBLE ANOMALY UNDER A1 AND A2. NOTE-FAN AREA ON A1 APPEARS WARMER THAN THE OTHER HVAC FANS. NO ANOMALIES SEEN IN SECTION D,E,F.

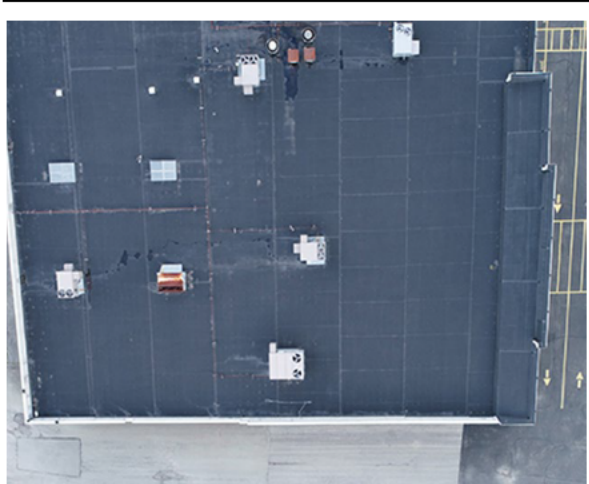
#10: BIRDS EYE VIEW OF STRUCTURE. VISABLE WATER LINES AROUND HVAC UNITS IN SECTIONS A AND C.

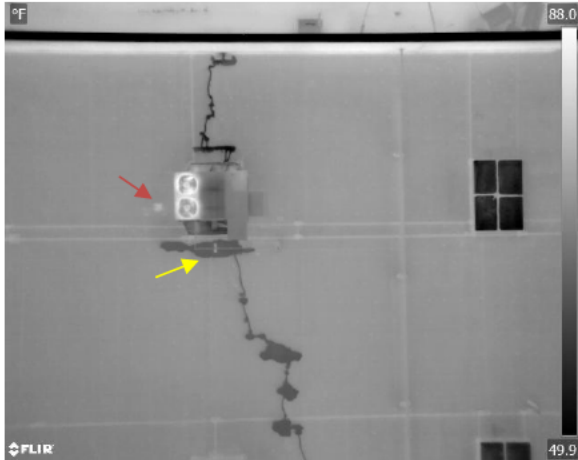
#13: A1 – SURFACE MOISTURE DETECTED ON WEST SIDE HVAC UNIT (YELLOW ARROW). THIS LINE OF SURFACE MOISTURE APPEARS WARMER THAN THE MOISTURE LINE NOTED ON THE EAST SIDE OF THE UNIT. SUSPECT SURFACE MOISTURE MIGRATED FROM HVAC UNIT C2. POSSIBLE ROOF ANOMALY ON NORTH SIDE OF A1. NOTE-FAN AREA ON A1 APPEARS WARMER THAN THE OTHER HVAC FANS.

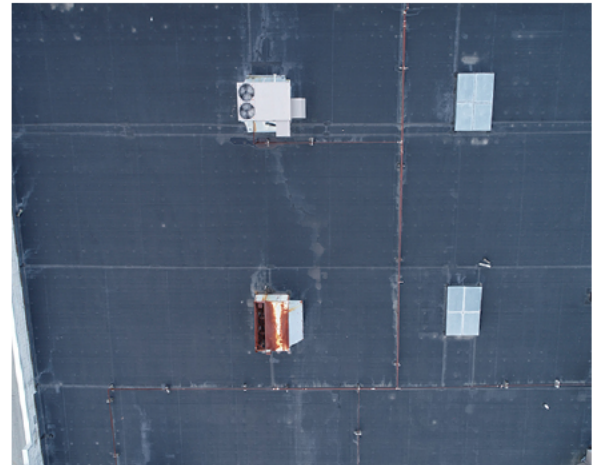
#14: SECTIONS A AND B (A1, A2, B1, B2). VISABLE WATER LINES AROUND HVAC UNITS.

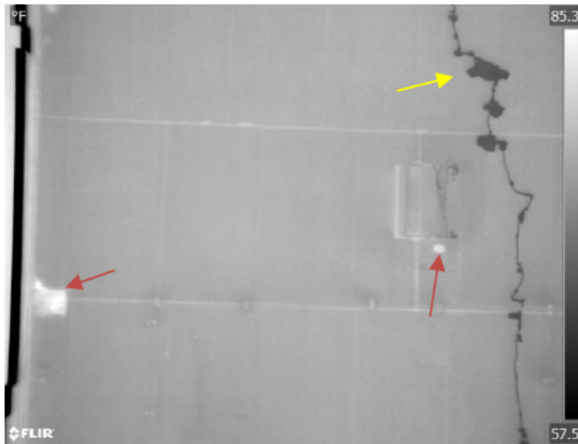
#15: A2 - SURFACE MOISTURE DETECTED (YELLOW ARROW). POSSIBLE ROOF ANOMALY ON NORTH SIDE WALL AND WEST SIDE OF UNIT.

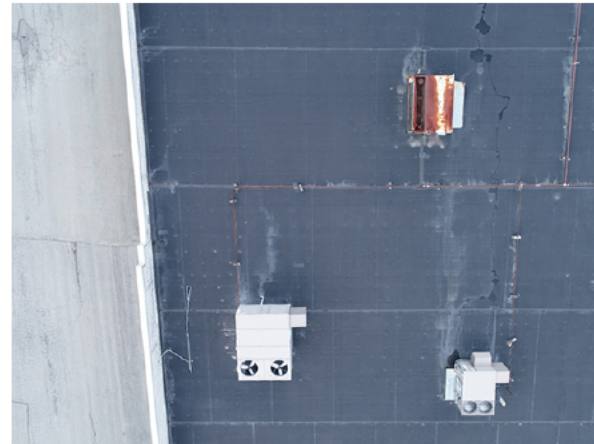
#16: SECTIONS A AND C (A2,C1,C2). VISABLE WATER LINES AROUND HVAC UNITS.

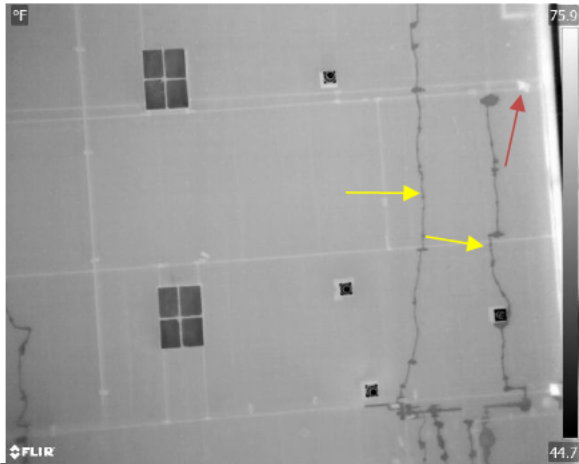
#17: SECTION B- NO ANOMALIES DETECTED AROUND B1,B2,B3,B4. SURFACE MOISTURE DETECTED FROM ADJOINING PROPERTY (YELLOW ARROWS). POSSIBLE ROOF ANOMALY ALONG SOUTH WALL.

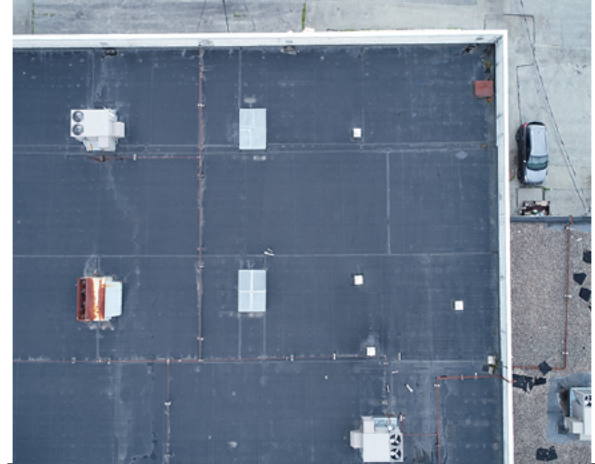
#18: SECTION B (B1,B2,B3,B4). VISABLE WATER LINES FROM ADJOINING PROPERTY HVAC UNITS.

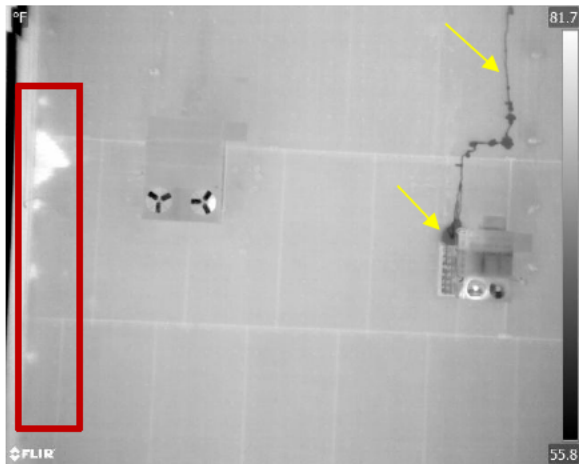
#19: SECTION C - SURFACE MOISTURE DETECTED ON EAST SIDE C2 HVAC UNIT (YELLOW ARROW). POSSIBLE ROOF ANOMALY ALONG NORTH WALL. NOTE-LEFT FAN AREA ON C2 APPEARS WARMER THAN RIGHT FAN.

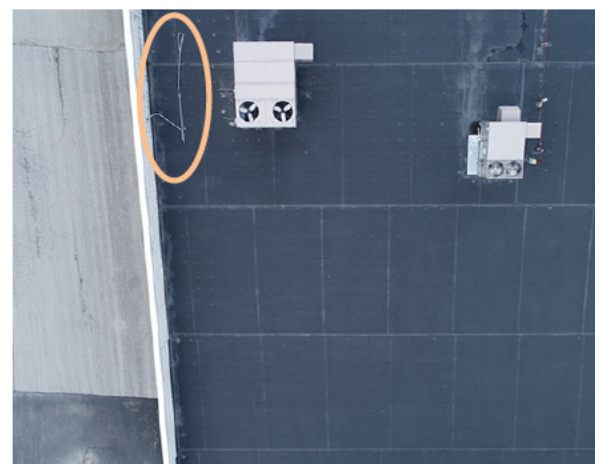
#20: SECTION C (C1 AND C2). VISABLE WATER LINES FROM BOTH HVAC UNITS. DEBRIS ALONG NORTH SIDE EDGE OF ROOF (ORANGE CIRCLE).
